BAYFIELD COUNTY LAND SURVEY MONUMENT RECORD

The northeast corner of Section 1, T. 47 N., R. 8 W., in the Town of Iron River, Bayfield County, Wisconsin.

SECTION 1, T. 47 N., R. 8 W.

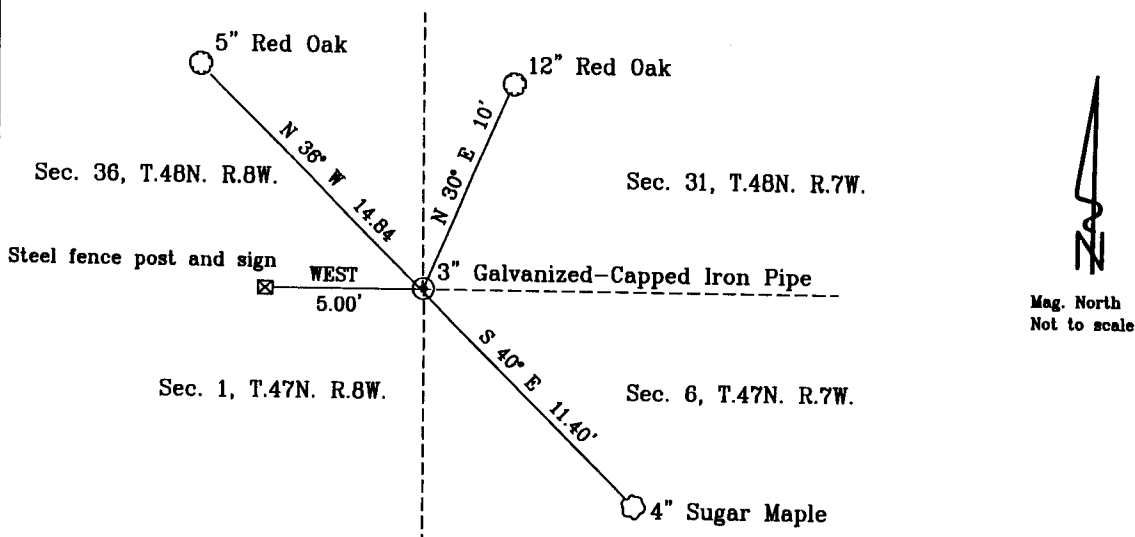
On October 31, 2005, I found a 3" galvanized-capped iron pipe, ±0.3 feet above ground level at the corner common to Sections 1, 6, 35 and 36.
