CERTIFIED LAND CORNER RESTORATION

I, Elwood L. Olson, do hereby certify that on the 20th day of June, 1967, I found evidence of the Quarter corner of Sections 35 and 36 Township 44 North, Range 6 West, Fourth Principal Meridian, as described hereon; and that from this evidence I established a new monument and accessories as described hereon to perpetuate the original location of this corner:

# Bayfield County Land Records Department

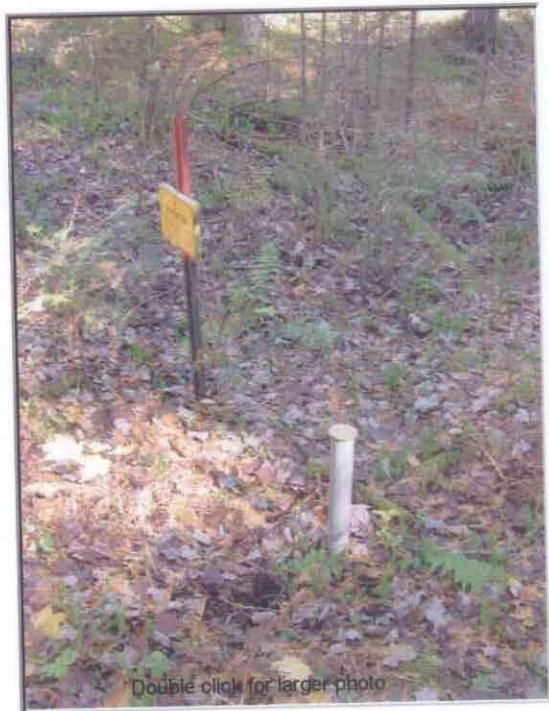
Photo of Monument

WI ID #	4406352000
Section	35
Town	44
Range	6
PLSS location	E 1/4 35
Monument Found	3" CAP
Condition of Monument	Undisturbed
Date of field work	10/17/01
Northing	333795
Easting	770667
Latitude	46.24852828
Longitude	-91.07109311
Date recorded	1858
Set by	D. NORTON
Date of perpetuation	6/22/1967
Perpetuated by	E. OLSON
Comment	
Rate of Coordinates	GPS sub-meter
Picture #1	0123.JPG
Picture #2	N/A
