CERTIFIED LAND CORNER RESTORATION

I, Elwood L. Olson, do hereby certify that on the 20th day of June, 1967, I found evidence of the Quarter corner of Sections 35 and 36 Township 44 North, Range 6 West, Fourth Principal Meridian, as described hereon; and that from this evidence I established a new monument and accessories as described hereon to perpetuate the original location of this corner:

# Bayfield County Land Records Department

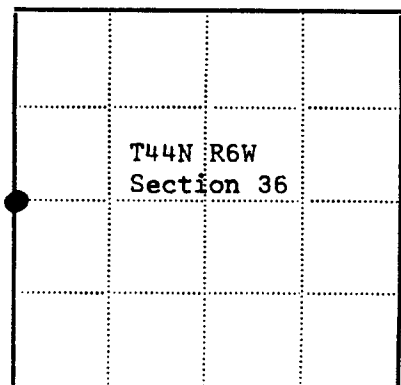
Corner marked by old squared wood stake alongside of which I found a very old squared stake laying under moss. From corner the decayed stump of the original Hemlock bearing tree with old inscription "1/4S" visible brs. S70°W, 15 links. Decayed stump of other original Hemlock bearing tree brs. N24°E, 15 links. Found Rykert's location poster on 17" dia. Hemlock brng. S49°W, 11.8 feet from corner. (Nailed new location poster on this tree) The corner is on the west edge of a small swamp.

● = Corner monument restored
