BAYFIELD COUNTY LAND SURVEY MONUMENT RECORD

The northeast corner of Section 1, T. 47 N., R. 8 W., in the Town of Iron River, Bayfield County, Wisconsin.

SECTION 1, T. 47 N., R. 8 W.

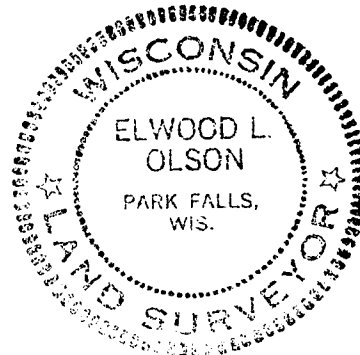
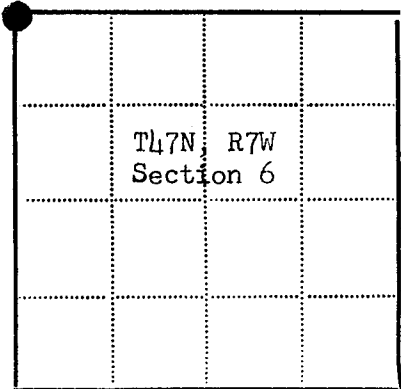
Corner marked by a 2" dia., galvanized iron pipe, extending 7" above ground and surrounded by a mound of stone, with a 3" dia., galvanized iron screw cap on top stamped: S.1, S.6, S.31, S.36. A 10" W. Pine stump with old blaze and scribe marks "WOTSHP" on it, brs. S40°E, 30.8 feet from pipe. The corner is on the west slope of a hill.

Blazed and scribed new bearing trees as follows:
Oak 6", N35°W, 14.2 feet.
Oak 9", N31°E, 9.8 feet.
Oak 6", S14°W, 16.7 feet.
Iron sign post, West, 2.3 feet.
