U.S. PUBLIC LAND SURVEY MONUMENT RECORD

Corner East Quarter
Section Section 36
Township 45 North
Range 07 West
Town/City/Village Drummond
Bayfield County

MAP OF SURVEY

U.S. GOVERNMENT LANDS BEING THE WEST 1/2, THE NORTHEAST 1/4, THE SOUTH 1/2 SOUTHEAST 1/4, THE NORTHEAST 1/4 SOUTHEAST 1/4 AND THE NORTH 1/2 NORTHWEST 1/4 SOUTHEAST 1/4 OF SECTION 36, TOWNSHIP 45 NORTH, RANGE 7 WEST, BAYFIELD COUNTY, WISCONSIN.

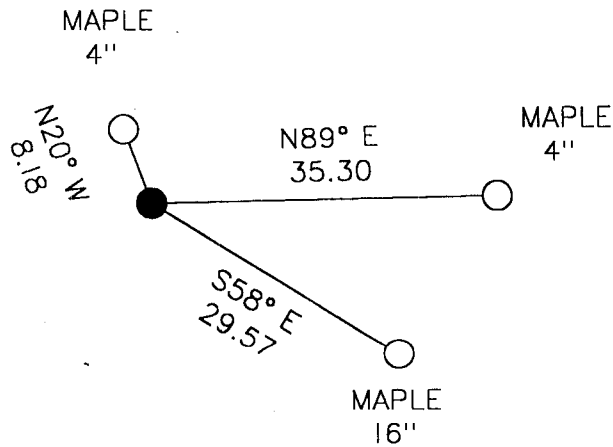
- 2" X 36" ALUMINUM PIPE MONUMENT WITH 3" CAP.
- BT MEASURED TO ALUMINUM NAIL IN SIDE OF TREE ABOVE CENTER OF ROOT CROWN.

SET STEEL SIGN POST NORTH 0.6 FEET

Found old metal sign nailed to Ash, East 9.0 feet from which we found post point under ground. Set a 2" x 36" aluminum pipe monument with a 3" alum. cap at point of post point. Monument extends 5" above ground.

Established Wisconsin North Zone State Plane Coordinates for corner:

N 428574.61 E 1671483.93 NAD 83 1991 U.S. foot
